NIOSH
Fire Fighter Fatality Investigation
and Prevention Program

A summary of a NIOSH fire fighter fatality investigation

Volunteer Deputy Fire Chief Dies after Falling Through Floor Hole in Residential Structure during Fire Attack—Indiana

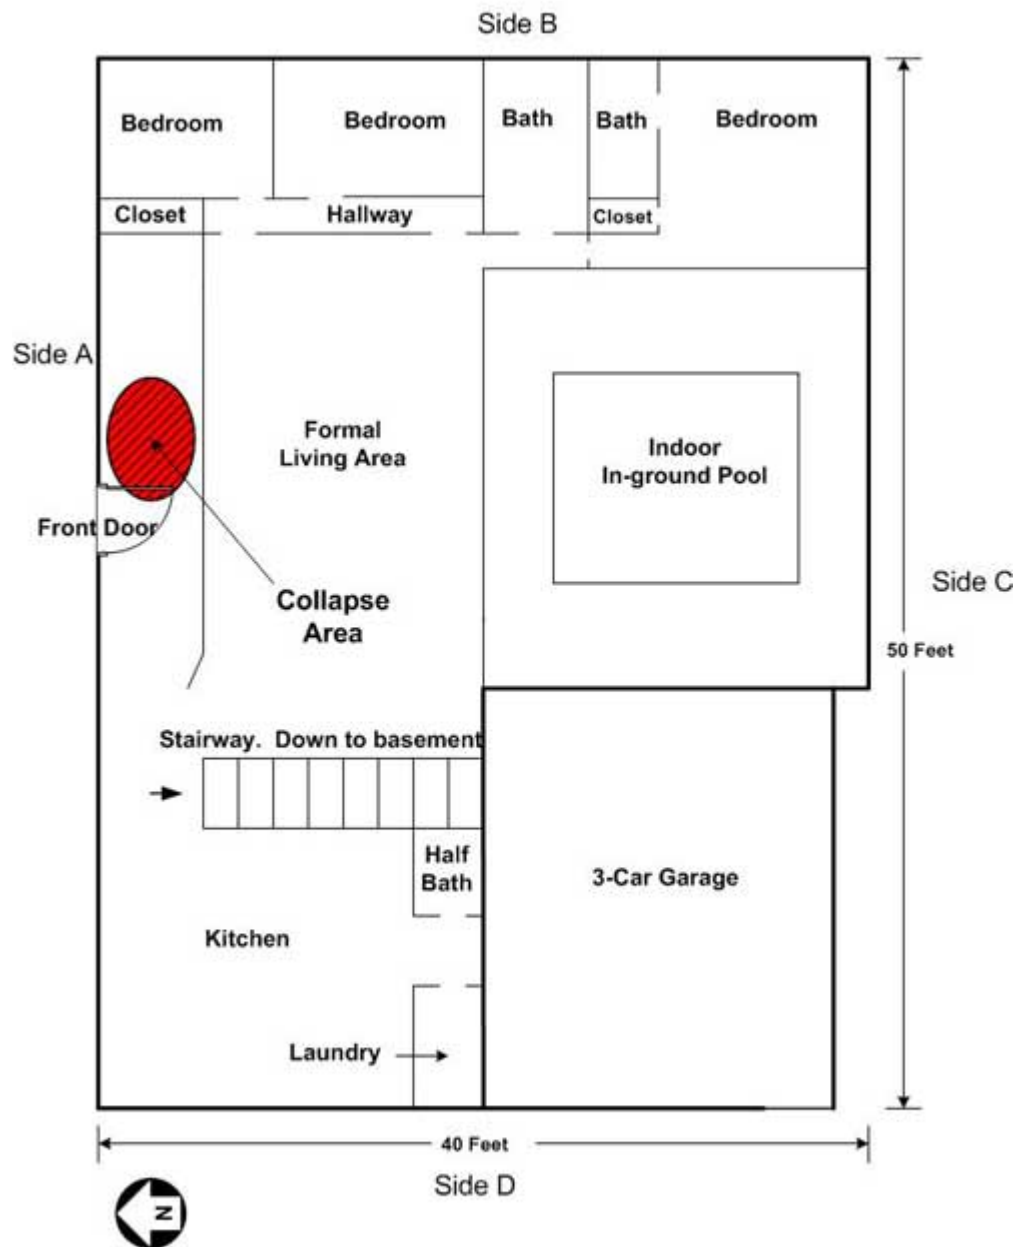
Figure 1. Main Level

The one-story ranch-style residential structure was approximately 2,000 sq. ft. (main floor) in size, and it was built in 2004 of wood-frame construction. There was a partial unfinished basement of approximately 1,200 sq. ft. The exterior was finished with horizontal vinyl siding. The main level flooring system was comprised of pre-engineered I-joists that measured 26' in length x 18" deep, with 3 ½" flanges. The joists were set 19 ½" on center. Two main beams supporting the system were 26' long and consisted of 2" x 12" laminated beams. The floor decking in the area of the hole consisted of ¾" oriented strand board (OSB), covered by ¼" luan and vinyl tile. The structure was heated and cooled via natural gas and electricity. There was a glass-enclosed porch covering an in-ground pool that was attached to Side C of the home ([Photo 1](#) and [Figure 1](#)).

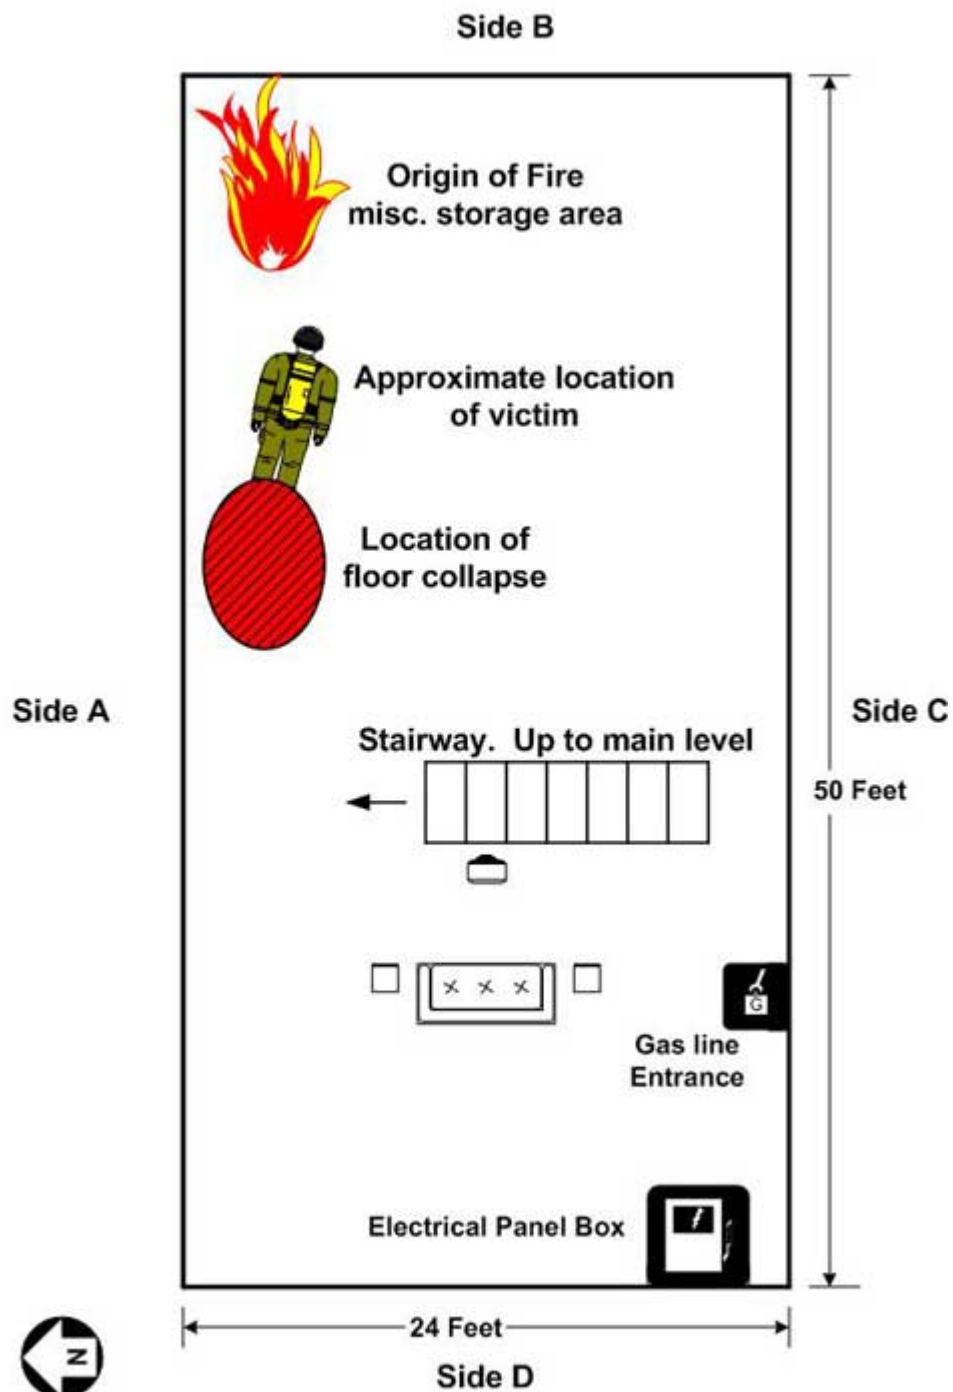
Figure 2. Basement Layout.

instructed FF#1 to stretch the additional line around to the B-side to hit the fire in the basement through a window (*Note: the basement window led to a crawl space, so no water actually hit the basement, or the fire*). Also, during this time, FF#2 set up a positive pressure ventilation (PPV) fan at the entrance on side A. The victim stayed at the front entrance (alone a second time) to reportedly attack the fire through the hole in the floor just to the left of the entrance (see [Photo 2](#) and [Figure 2](#)).
